Manhole Inspection Summary

Manhole # S15SS1016MH

Insp Date: **6/20/07 3:28 PM**

Location Address: **CYLBURN AVE**

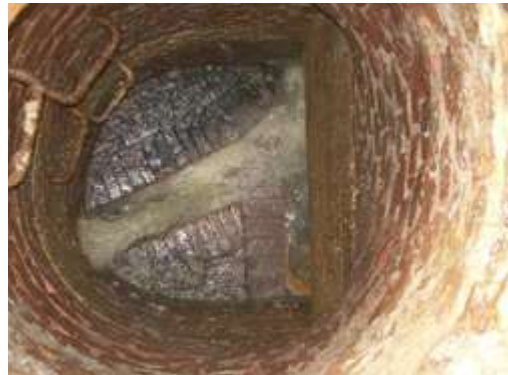
Top View

Corroded steps. Bench debris.

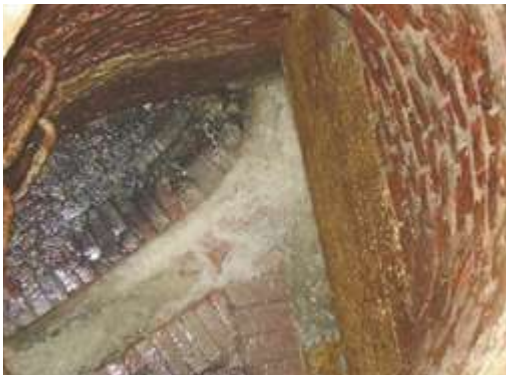
Defect

Adjustment deterioration and infiltration.
Corbel and Barrel infiltration - other side.

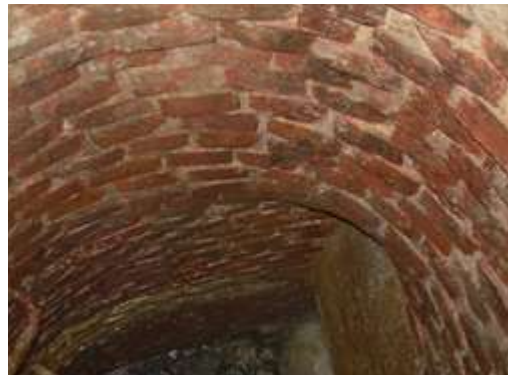
Defect

Adjustment deterioration and infiltration.
Barrel infiltration.

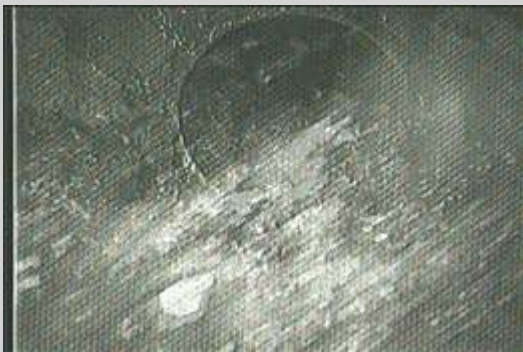
10 in. Circular Gravity Sewer Pipe Out @ 12 O'Clock

Infiltration: **Evidence** Pipe Seal Cond: **Cracked**

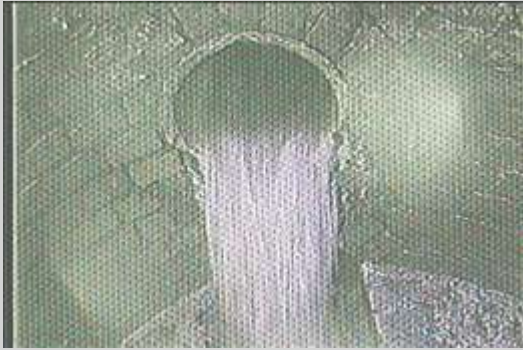
Pipe In @ 9 O'Clock

Barrel deterioration and infiltration.

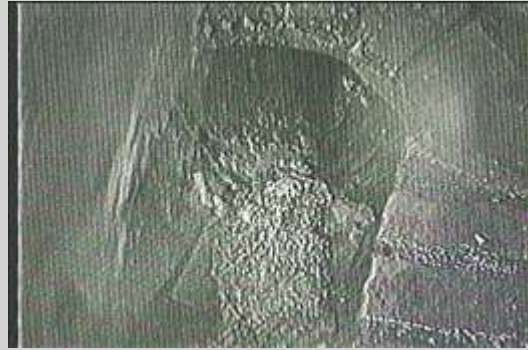
Drop In @ 9 O'Clock

Deposits: ☐ None ☐ Mud ☐ Sludge ☒ **Debris** ☒ **Grease**

Infiltration: **Evidence** Pipe Seal Cond: **Cracked**

Drop Condition: **Clogged**
